CITY OF KIRKLAND TREE REMOVAL NOTIFICATION

Case No. TRE11-00454

Tree Assessment
Firwood Lane Mobile Home Park
NE 93rd Lane, Kirkland

9/6/2011

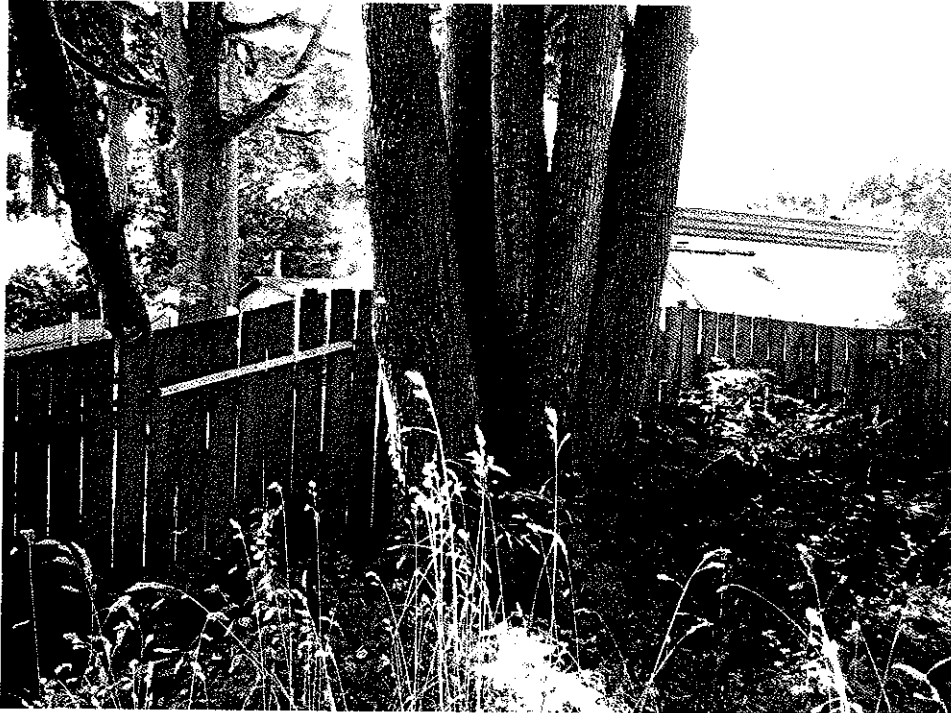
Addendum I – Site/Tree Photos
Tree #101

Tree #101 is a large clump of big leaf maple, made up of five stems or trunks. See photos in Addendum I. The trunks are tightly spaced and poorly attached to each other. Four of the five stems are in drastic decline, as evidenced by dead and dying foliage and upper branches. It is considered high risk.

Tree #101 is in serious decline. The tightly spaced trunks have a high potential for failure, by means of splitting away from the clump. Removal and replacement is recommended.

The removal of Tree #101 is recommended to abate hazard risk.

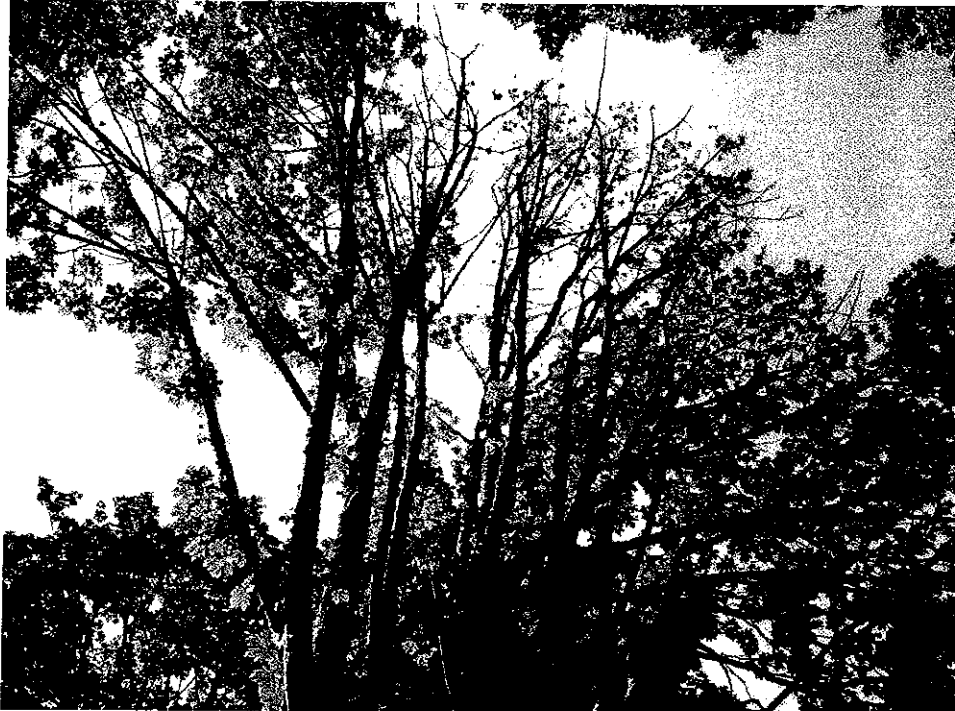
Crown of Tree #101, significant decline and dieback

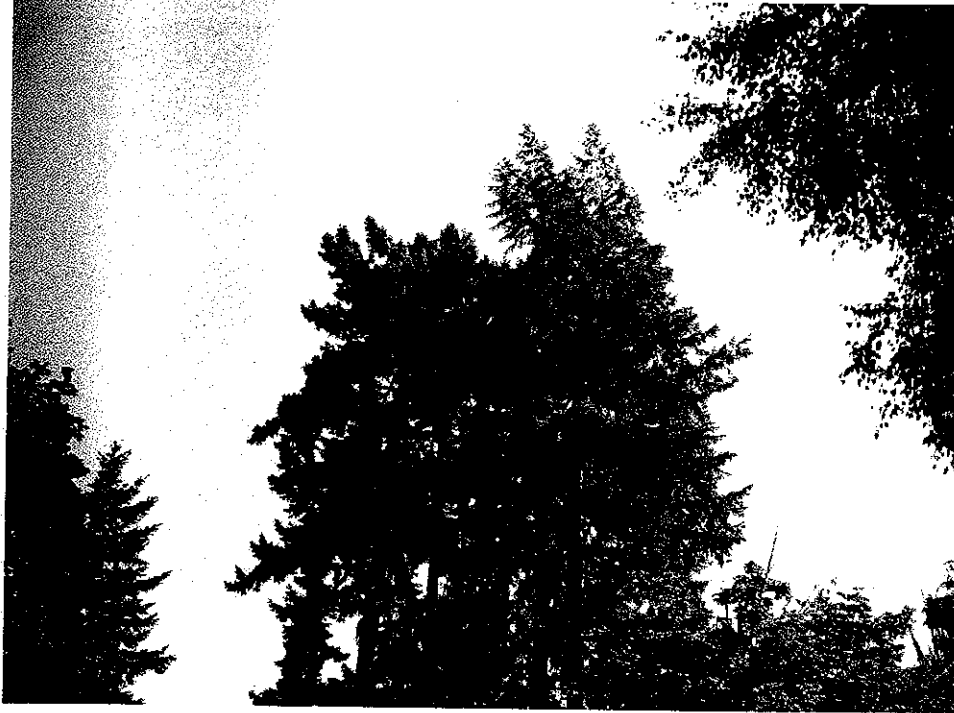
Tree #102 is a semi-mature Douglas-fir. Like most of the other Douglas-fir on the property, it was topped several years ago. Foliage color and density is good. No indicators of lower stem decay were observed, however a small cavity was identified on the east side of the stem at approximately 70' above ground. Total tree height is 106'. The opening appears to be approximately 6 inches long by two inches wide. Pitch appears to be gradually oozing from this opening.

Tree #102 appears sound and stable, however the small cavity on the upper bole is concerning. Given the trees proximity to a mobile home and the potential for damage; an aerial inspection is recommended to evaluate the extent of decay in the upper cavity.

Tree #102, tree farthest to the right

An aerial inspection is recommended for Tree #102 to evaluate the extent of decay in the small cavity on the east side of the upper bole. Tree Solutions Inc. can provide you with this service. Their phone number is 206-528-4670.

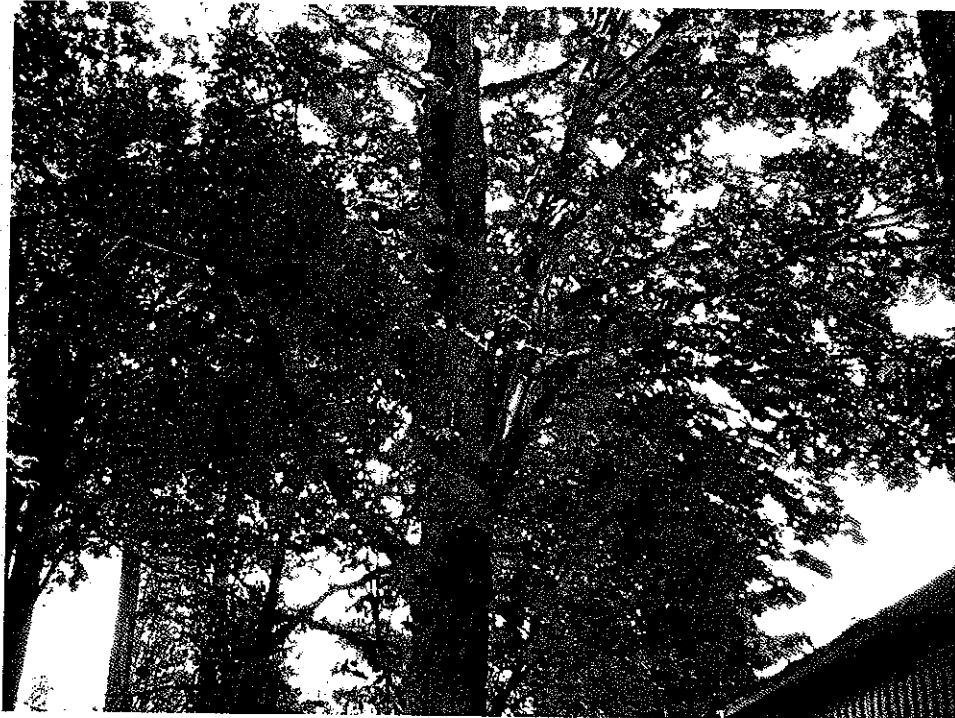
Tree #103 is a mature big leaf maple. Noteworthy decay was identified on the lower trunk associated with *Hypoxylon duestrum*. Many branches in the upper crown have recently died back. Vigor appears to be in decline.

Tree #103 is in need of crown cleaning and end-weight reduction pruning on the mobile home side to reduce hazard risk and the potential for damage from branch failures. Reduce the length of long laterals over the mobile home to a smaller side branch.

Crown cleaning and /or end-weight reduction is necessary for Trees #103, #104 and #105 to reduce the risk of large branch or trunk failures.

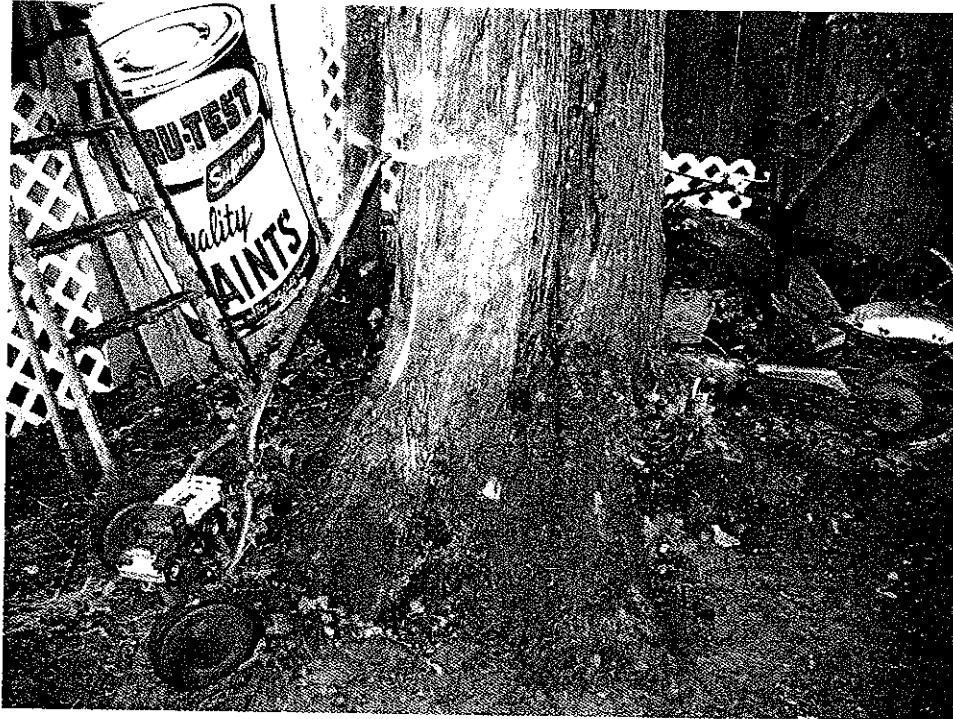
Base of Tree #103

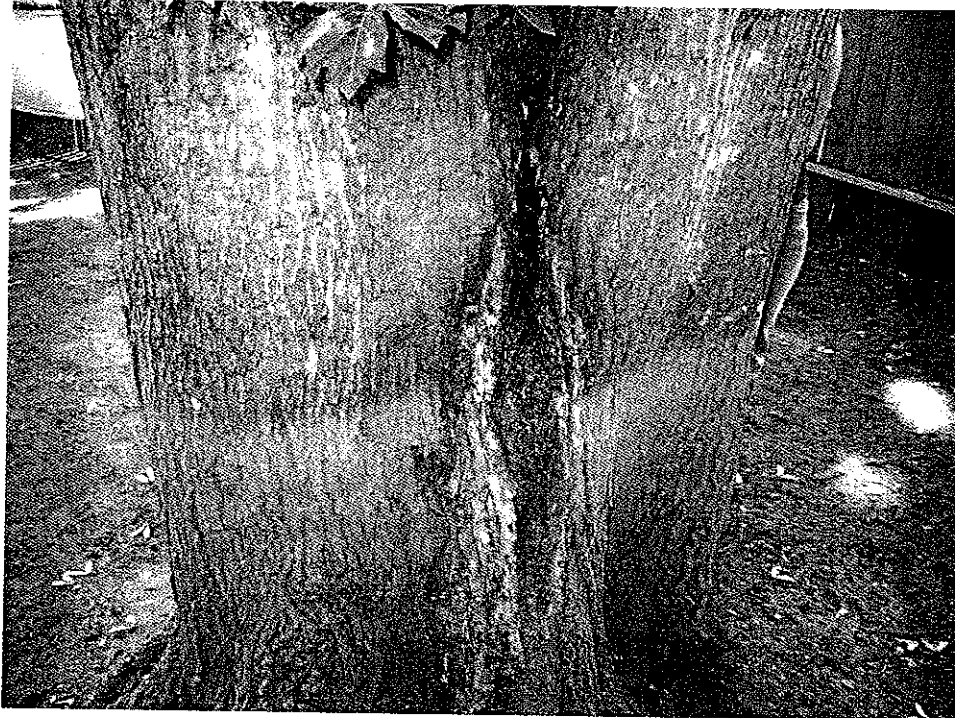
Tree #104 is also a mature big leaf maple. This tree has codominant stems which is a significant structural defect. The buildup of included bark between the two trunks is considerable. If left as is, the smaller trunk on the mobile home side will likely split away as decay advances between the stems. The foliage is of normal color and density. Overall vigor appears good.

On Tree #104, crown reduction pruning of the smaller fork is necessary to reduce the risk of trunk failure. Reduce the length of long laterals over the mobile home to a smaller side branch.

Codominant stems of Tree #104

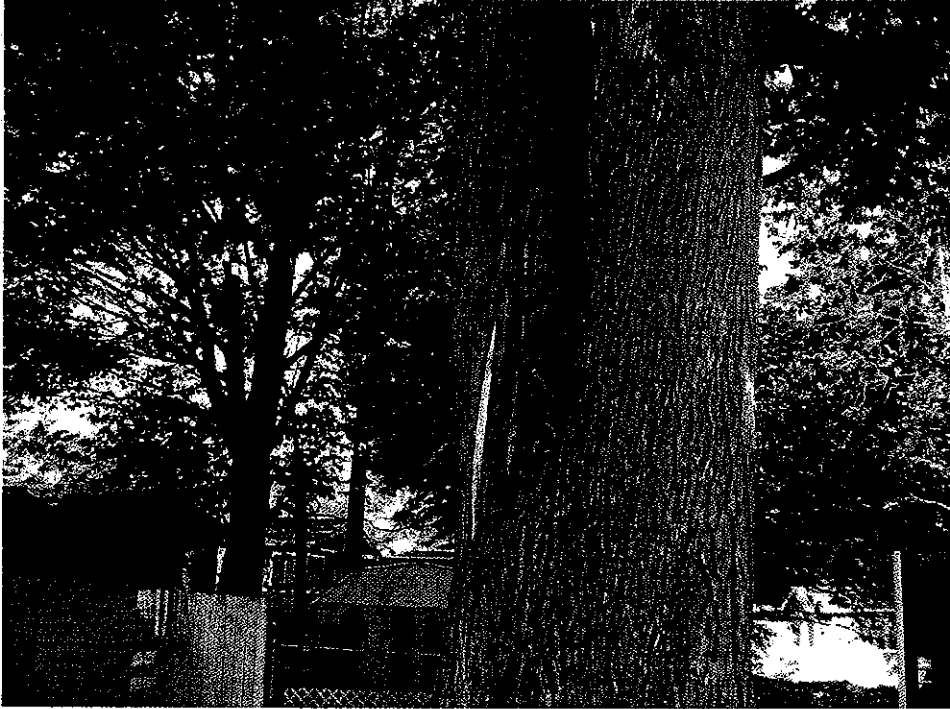
Tree #105 is another mature big leaf maple located in the playground area. Noteworthy decay was identified in the lower trunk, root crown and on some of the larger scaffold branches. Large accumulations of deadwood exist in the crown. Risk of deadwood failure is high. Overall condition is fair to poor.

Crown cleaning tree #105 will reduce the risk of branch failures. Gradual decline is anticipated over the next several years. Crown cleaning will be necessary every four to five years as deadwood develops to retain the tree in a safe condition. It is possible the tree could be retained with proper maintenance for another +/- 20 years. Given the trees current condition and future maintenance requirements, removal and replacement may be the best option for your needs.
